Flow and Scouring Processes around the RCC Spurs

Mohammad Nazim Uddin¹ and Md. Munsur Rahman²

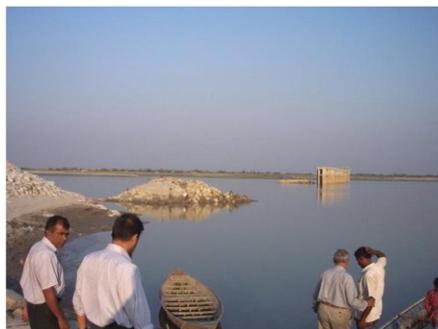
mouths and RCC-parts of both spurs were strengthened by dumping of CC-blocks and geo-bags. Failure of the earthen shank or belmouth (connection of earthen shank and RCC) occurred of the both spurs several times during the monsoon since their construction. The earthen shank of both spurs washed away during the flood of 2004. The disconnected RCC part of the Betil spur is shown in Fig. 3. The RCC part of the Betil spur opened and water started to flow beneath the RCC part. Since then it is working as a permeable spur or to some extent as bandal-like structure. Bandal is a low cost bank protection structures. The upper half of the portion is blocked by bamboo thatched and the half of the portion is opened. A major rehabilitation works performed in 2006. During rehabilitation works RCC blocks are dumped as launching apron at a rate 25m³/m close to the RCC portion and 20 to 50m³/m at the earthen shank and belmouth. Almost every year a portion of the earthen shank damages and a huge amount of maintenance budget is required to repair the failure part. The failure of the earthen shank of the Enayetpur spur in 2007 is shown in Fig. 4.

Fig. 3. Washed out of the earthen shank of the Betil spur (2004)

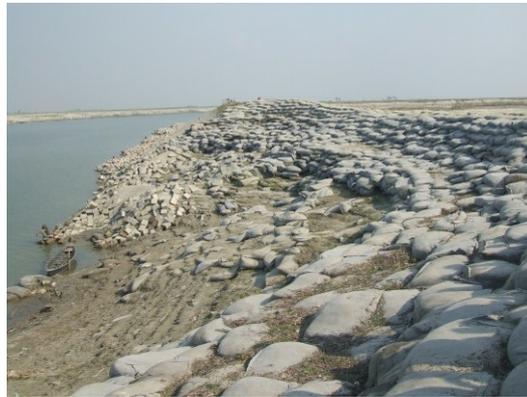
Fig. 4. Failure of the earthen shank of the Enayetpur spur

The main causes of the failure of the earthen shank of the Enayetpur spur are (Fig. 4): (i) the striking of flow obliquely to the earthen shank, (ii) the generating of a strong parallel flow upstream of the earthen shank and RCC part of the spur, (iii) flow circulation normal to the earthen shank and the belmouth, and (iv) development of a deeper channel upstream of both spurs by the higher sediment carrying capacity parallel flow. The deeper channel near the earthen shank affects the structural stability of the earthen shank. Due to above reasons the earthen shank of the spurs frequently failed. Rahman et al. [15] proposed a conceptual model as shown in Fig. 17 to protect the bank as well as the earthen shank of the RCC spur from the oblique flow using bandal-like structures in between spurs or earthen shank of the spur. One of the big challenges for the bandal-like structures is that the selections of durable materials during its construction in reality in a large scale sand bed river like the Jamuna.

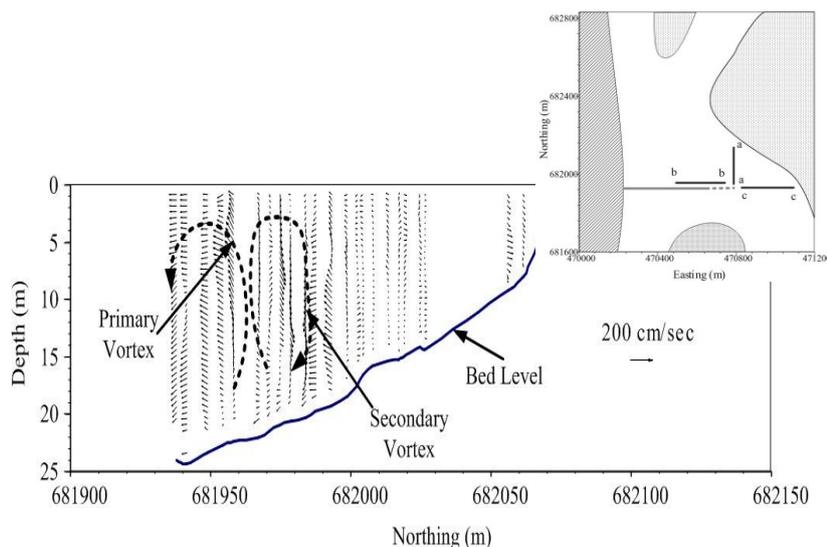
Fig. 11. The primary and secondary vortex around the Betil spur along line a-a

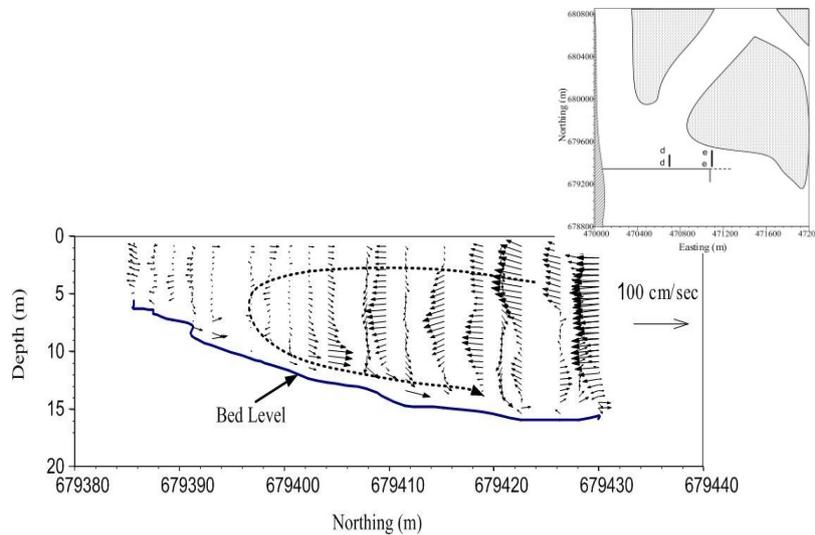
During the hydraulic data measurement it is found (15th July, 2008) that the earthen shank of the Enayetpur spur damaged. To identify the flow phenomena adjacent to the failure portion of the earthen shank a vertical

section is taken along line d-d normal to the earthen shank. The direction of the flow through the upper portion flow is towards the earthen shank. But the direction of flow near the bed level is outward from the earthen shank (Fig. 13). As a result the bed materials are washed away by the outward near-bed-level flow. The lurching materials are dislocated and a create gap between CC blocks. The soil particles from the gap of CC blocks are washed out. If this process is continued deeper channel is developed near the earthen shank. The upper part of the earthen shank slides down if the driving force exceeds the resisting force. Usually, a slip circle failure of the earthen shank is found. The failure of the earthen shank (Fig. 4) is occurred due to the above type of flow phenomena (Fig. 14 and Fig. 15). Another vertical section normal to the Enayetpur spur (adjacent to the belmouth) is taken along line e-e. The flow circulation is observed along line e-e (Fig. 15). This type of flow patterns (similar to secondary current at a bend) is usually observed around the Betil and the Enayetpur spurs. The median bed materials size d_{50} is 0.2mm at the study area. The variation of the ratio of the shear velocity along line e-e is shown in Fig. 16. The critical shear velocity u_{*c} is 1.5 cm/sec. The ratio of u_* / u_{*c} is 5 near the belmouth of the RCC spur which is much more than critical shear velocity ratio (i.e. one). So, the sediment particles are transported by the flow circulation from near the earthen shank of the RCC spur towards the sand bar. Resulting deep channel is developed near the spur which is a big threat to the structural stability of the spur.

Fig. 14. Flow circulation around the Enayetpur spur along line d-d

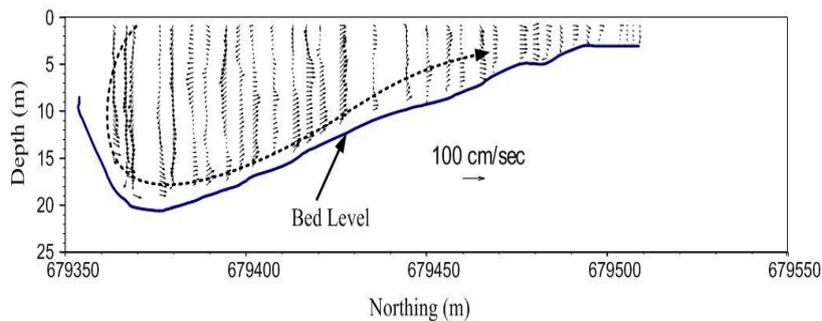
Fig. 15. Flow circulation around the Enayetpur spur along line e-e

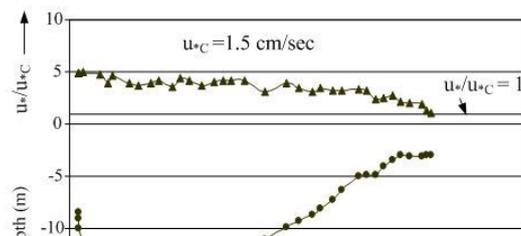
Fig. 16. The variation of the ratio of the shear velocity along line e-e
