Flow and Scouring Processes around the RCC Spurs

Mohammad Nazim Uddin¹ and Md. Munsur Rahman²

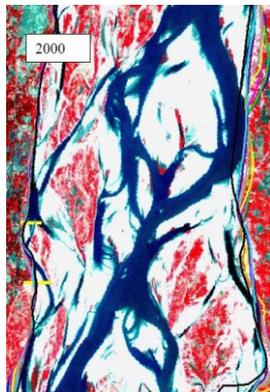
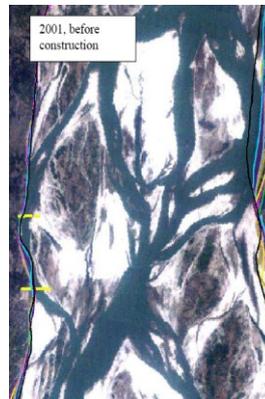
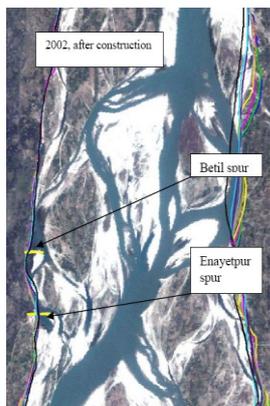
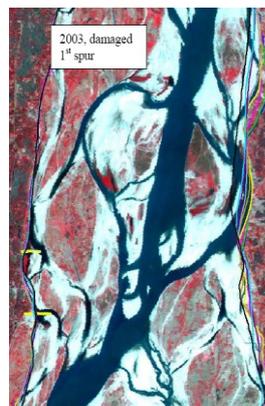
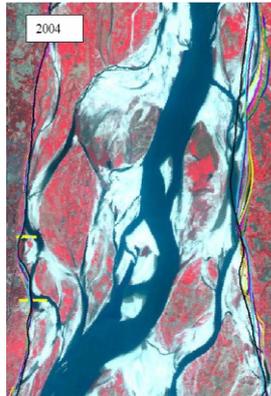
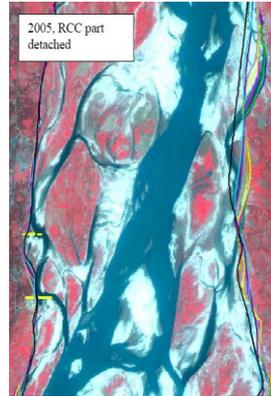
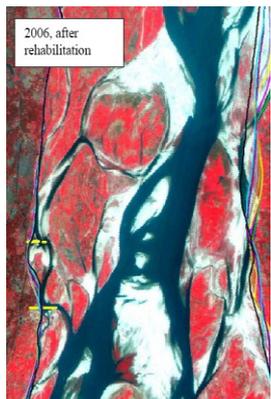
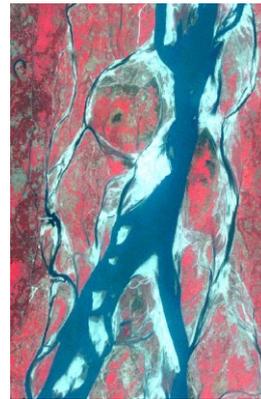
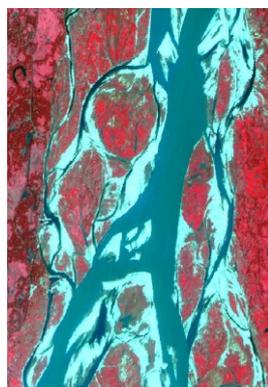
Fig. 6. Change of the morphology around the Betil and the Enayetpur spurs

The morphological change around the Betil and the Enayetpur are shown through satellite images. A series of satellite images from 2000 to 2008 are shown in Fig. 6. A branch channel was passing near Betil and Enayetpur area in 2000 before construction of the spurs. The channel became relatively wider in 2001. The Betil and the Enayetpur spurs were constructed in fiscal year 2001-2002. A small sandbar is formed just downstream of the Betil spur after construction of it. The sandbar became larger in 2003. A channel is developed parallel to the Enayetpur spur. The earthen shanks of the both spurs were washed away during 2004 flood season. The channel in between the Betil and the Enayetpur spurs is turned into wider. After a major rehabilitation works in 2006 the morphology around both spur is stable. Though, almost every year the earthen shank of the both spurs are damaged during high flood.

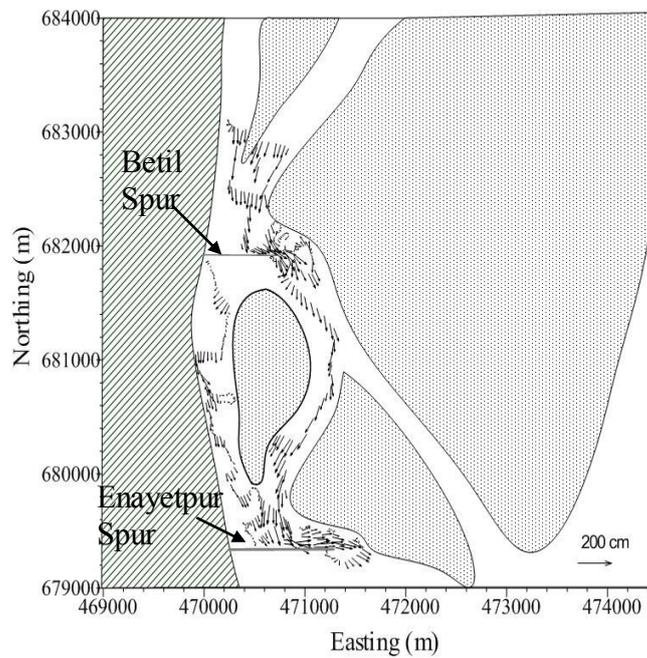
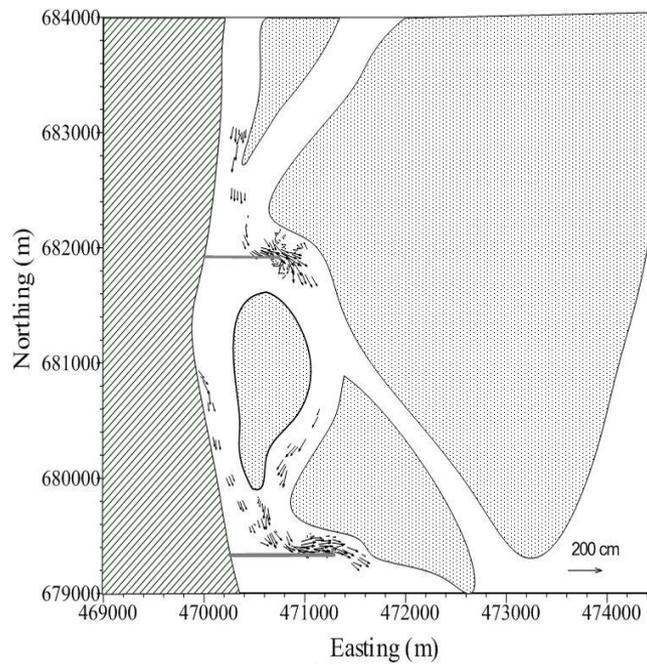
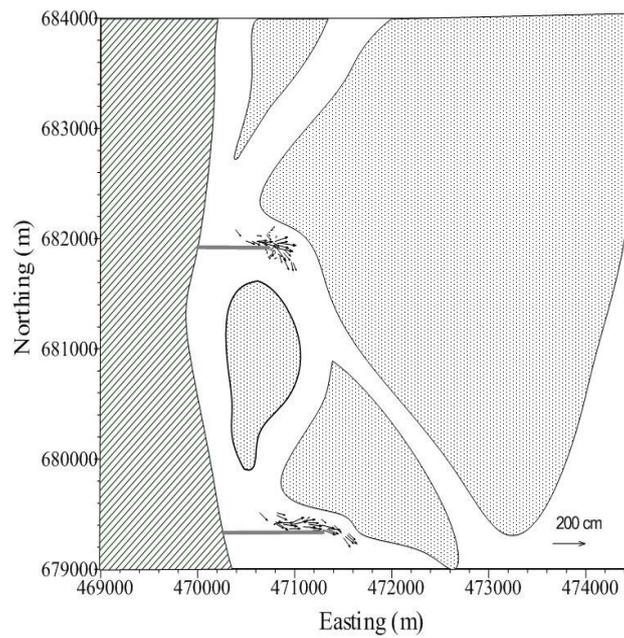
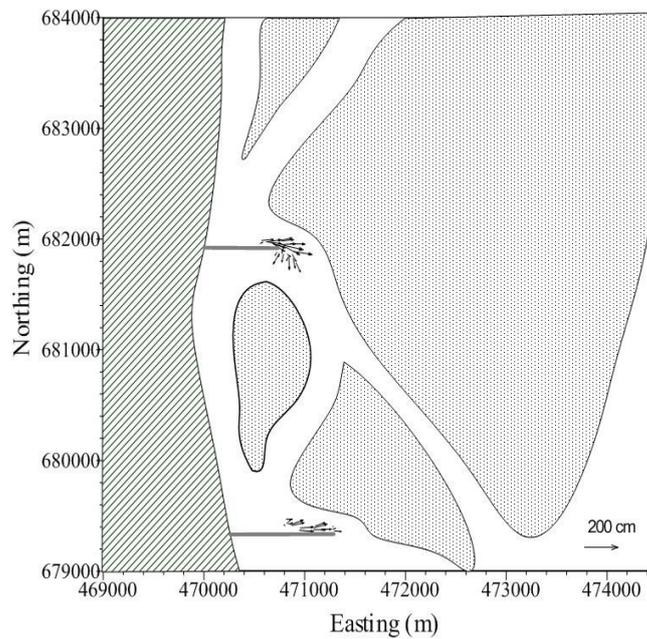
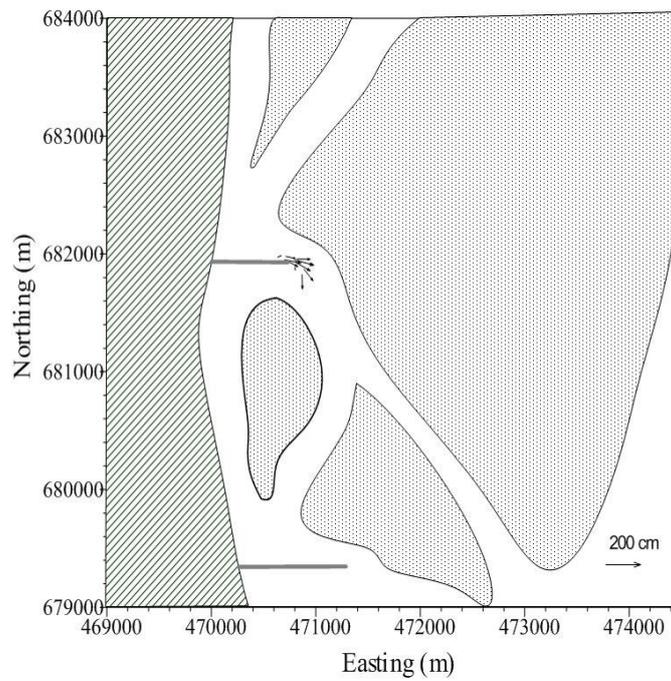
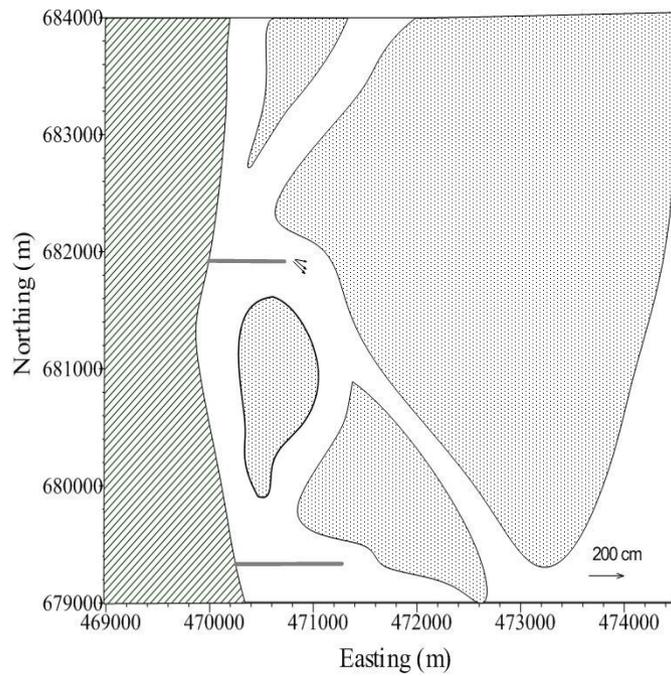
Fig. 8. 2-D velocity vectors around Betil and Enayetpur spurs at different depths (July, 2008)

The oblique flow hit to the earthen shank of the Betil spur. It is found that the strong parallel flow is generated upstream of both spurs. The approach average flow velocity upstream of the Betil spur is 0.7 m/s. The parallel flow velocity is amplified up to 1.75 times than approach average flow velocity adjacent to the Betil spur. Usually, a return current is generated downstream of a spur due to flow separation. It is found that some of the RCC spurs along the Jamuna River were damaged due to a strong return current [18]. The length of the RCC spurs is selected depending on the overall width of the braided jamuna river during its design. The secondary channels behave as an individual channel when it is separated from main channel by large sand bar. The length of the secondary channel is relatively higher with respect to the width of the secondary channel. As a

result the strong parallel flow is generated along the earthen shank of the RCC spurs.

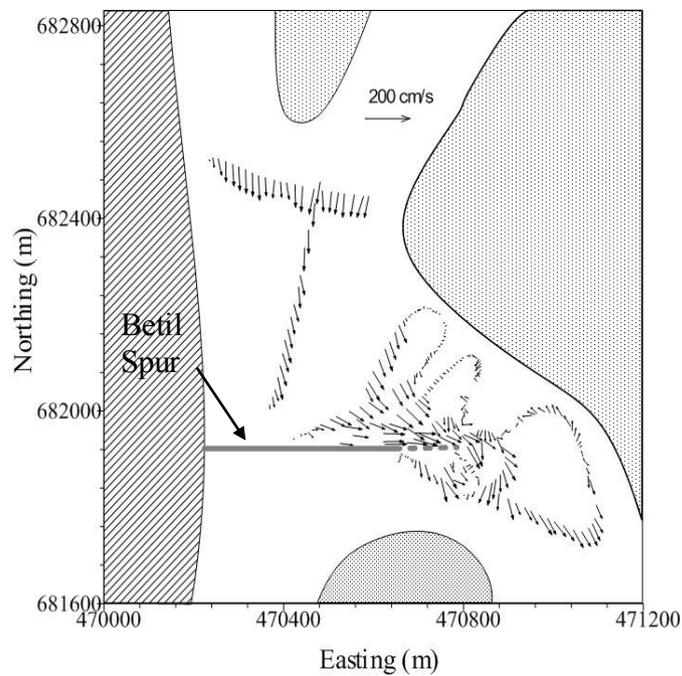
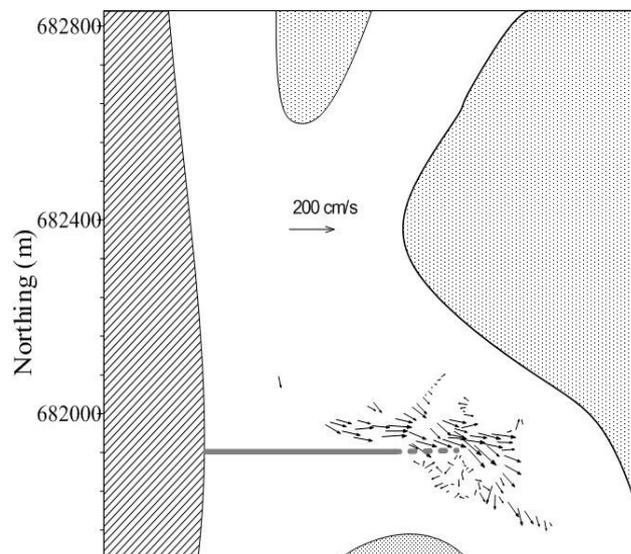
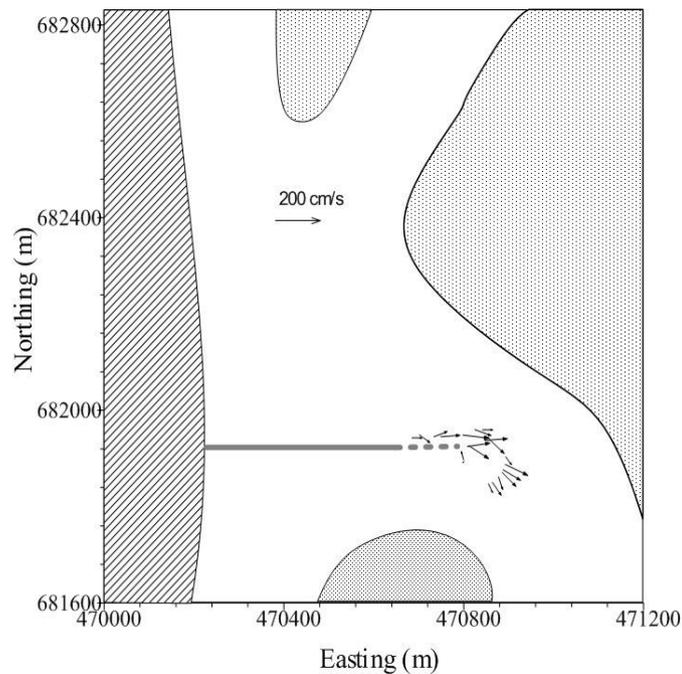
Fig. 9. 2-D Velocity vectors around Betil spur at different depths (July, 2008)

It is clearly found in Fig. 9 (a-c) that the return current is counter-balanced by the flow passing beneath the RCC part of the Betil spur. A reverse circulation of the flow is found adjacent to the bar (located opposite to the nose of the RCC part).

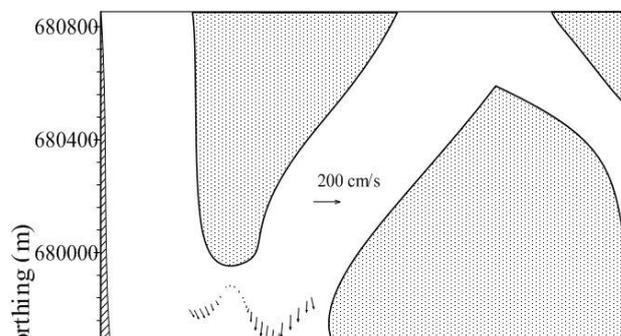
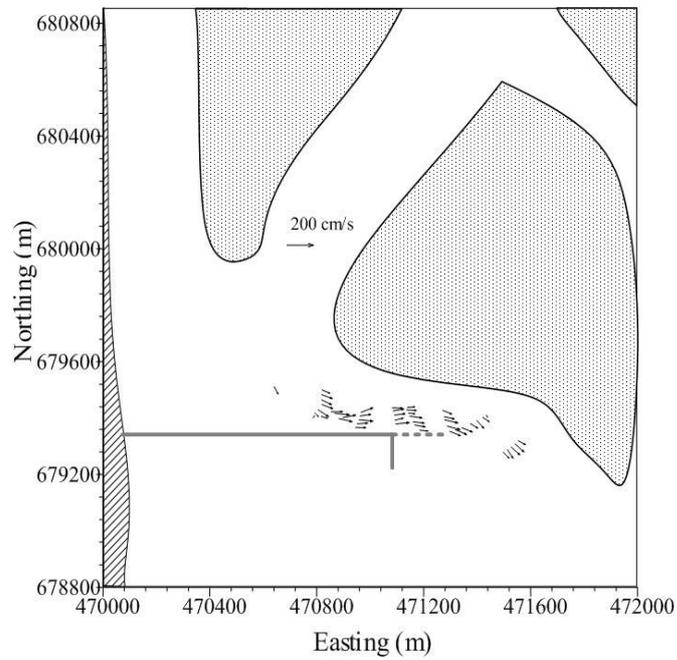
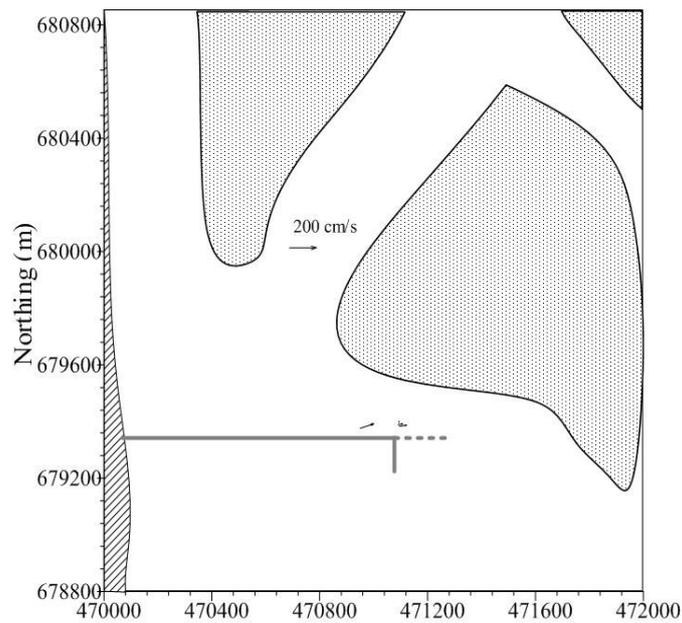
Fig. 10. 2D-Velocity vectors around Enayetpur spur at different depths (July, 2008)

The flow patterns along the horizontal plane around the Enayetpur spur at a depth of 1m, 5m, 10m and 15m are shown in Fig. 10 (a-d). The oblique flow hit to the earthen shank of the Enayetpur spur. A strong parallel flow is generated upstream of the Enayetpur spur which is similar to that of the Betil spur. The approach average flow velocity is 0.5 m/s. But the parallel flow velocity is amplified adjacent to the Enayetpur spur up to 2.3 times than approach average flow velocity. Though, the approach average flow velocity of the Enayetpur spur is less than that of Betil spur. But the amplification is higher in the case of the Enayetpur spur than the Betil spur.

An earthen cross dam, normal to the earthen shank of the Enayetpur spur, has been built by the local people to prevent the return current. A weak return current is found at the backside of the RCC part of the Enayetpur spur due to the cross dam. The elevated land existed downstream side of a RCC spur is very effective for the stability of the spur. It is already stated that the measured maximum scour depths around the Betil and the Enayetpur spurs on 17th July 2008 were 28m and 18m, respectively. The maximum scour depth around the Betil spur is 10m higher than that of the Enayetpur spur. One important point is that the magnitude of the parallel flow velocity is amplified up to 2.3 times upstream of the Enayetpur spur than approach average velocity. The parallel flow velocity is amplified up to 1.75 times than approach average flow velocity adjacent to the Betil spur. The Enayetpur spur is 250m longer than the Betil spur. It can be concluded that the amplification of flow velocity upstream of the Enayetpur is higher due to longer spur.

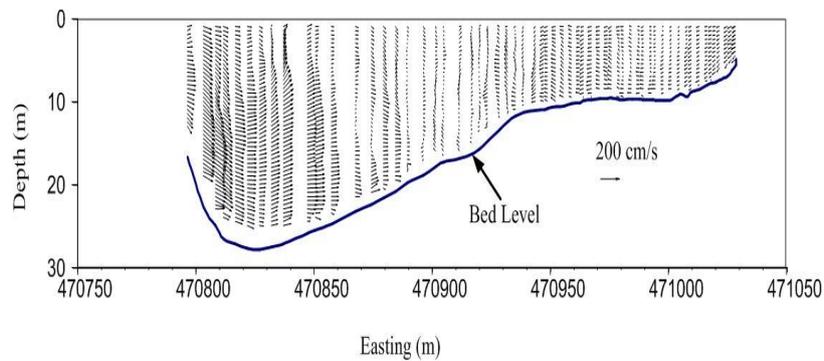
Fig. 13. Velocity vectors in the vertical plane around the Betil spur along line c-c
Enayetpur spur

During the hydraulic data measurement it is found (15th July, 2008) that the earthen shank of the Enayetpur spur damaged. To identify the flow phenomena adjacent to the failure portion of the earthen shank a vertical

section is taken along line d-d normal to the earthen shank. The direction of the flow through the upper portion flow is towards the earthen shank. But the direction of flow near the bed level is outward from the earthen shank (Fig. 13). As a result the bed materials are washed away by the outward near-bed-level flow. The lurching materials are dislocated and a create gap between CC blocks. The soil particles from the gap of CC blocks are washed out. If this process is continued deeper channel is developed near the earthen shank. The upper part of the earthen shank slides down if the driving force exceeds the resisting force. Usually, a slip circle failure of the earthen shank is found. The failure of the earthen shank (Fig. 4) is occurred due to the above type of flow phenomena (Fig. 14 and Fig. 15). Another vertical section normal to the Enayetpur spur (adjacent to the belmouth) is taken along line e-e. The flow circulation is observed along line e-e (Fig. 15). This type of flow patterns (similar to secondary current at a bend) is usually observed around the Betil and the Enayetpur spurs. The median bed materials size d_{50} is 0.2mm at the study area. The variation of the ratio of the shear velocity along line e-e is shown in Fig. 16. The critical shear velocity u_{*c} is 1.5 cm/sec. The ratio of u_* / u_{*c} is 5 near the belmouth of the RCC spur which is much more than critical shear velocity ratio (i.e. one). So, the sediment particles are transported by the flow circulation from near the earthen shank of the RCC spur towards the sand bar. Resulting deep channel is developed near the spur which is a big threat to the structural stability of the spur.
